# Puamana Homeowners Association

## Wood Restoration Project

Helping a 97-unit community in Princeville, Kauai preserve existing wood and avoid an estimated **\$1.4 million** in replacement costs.

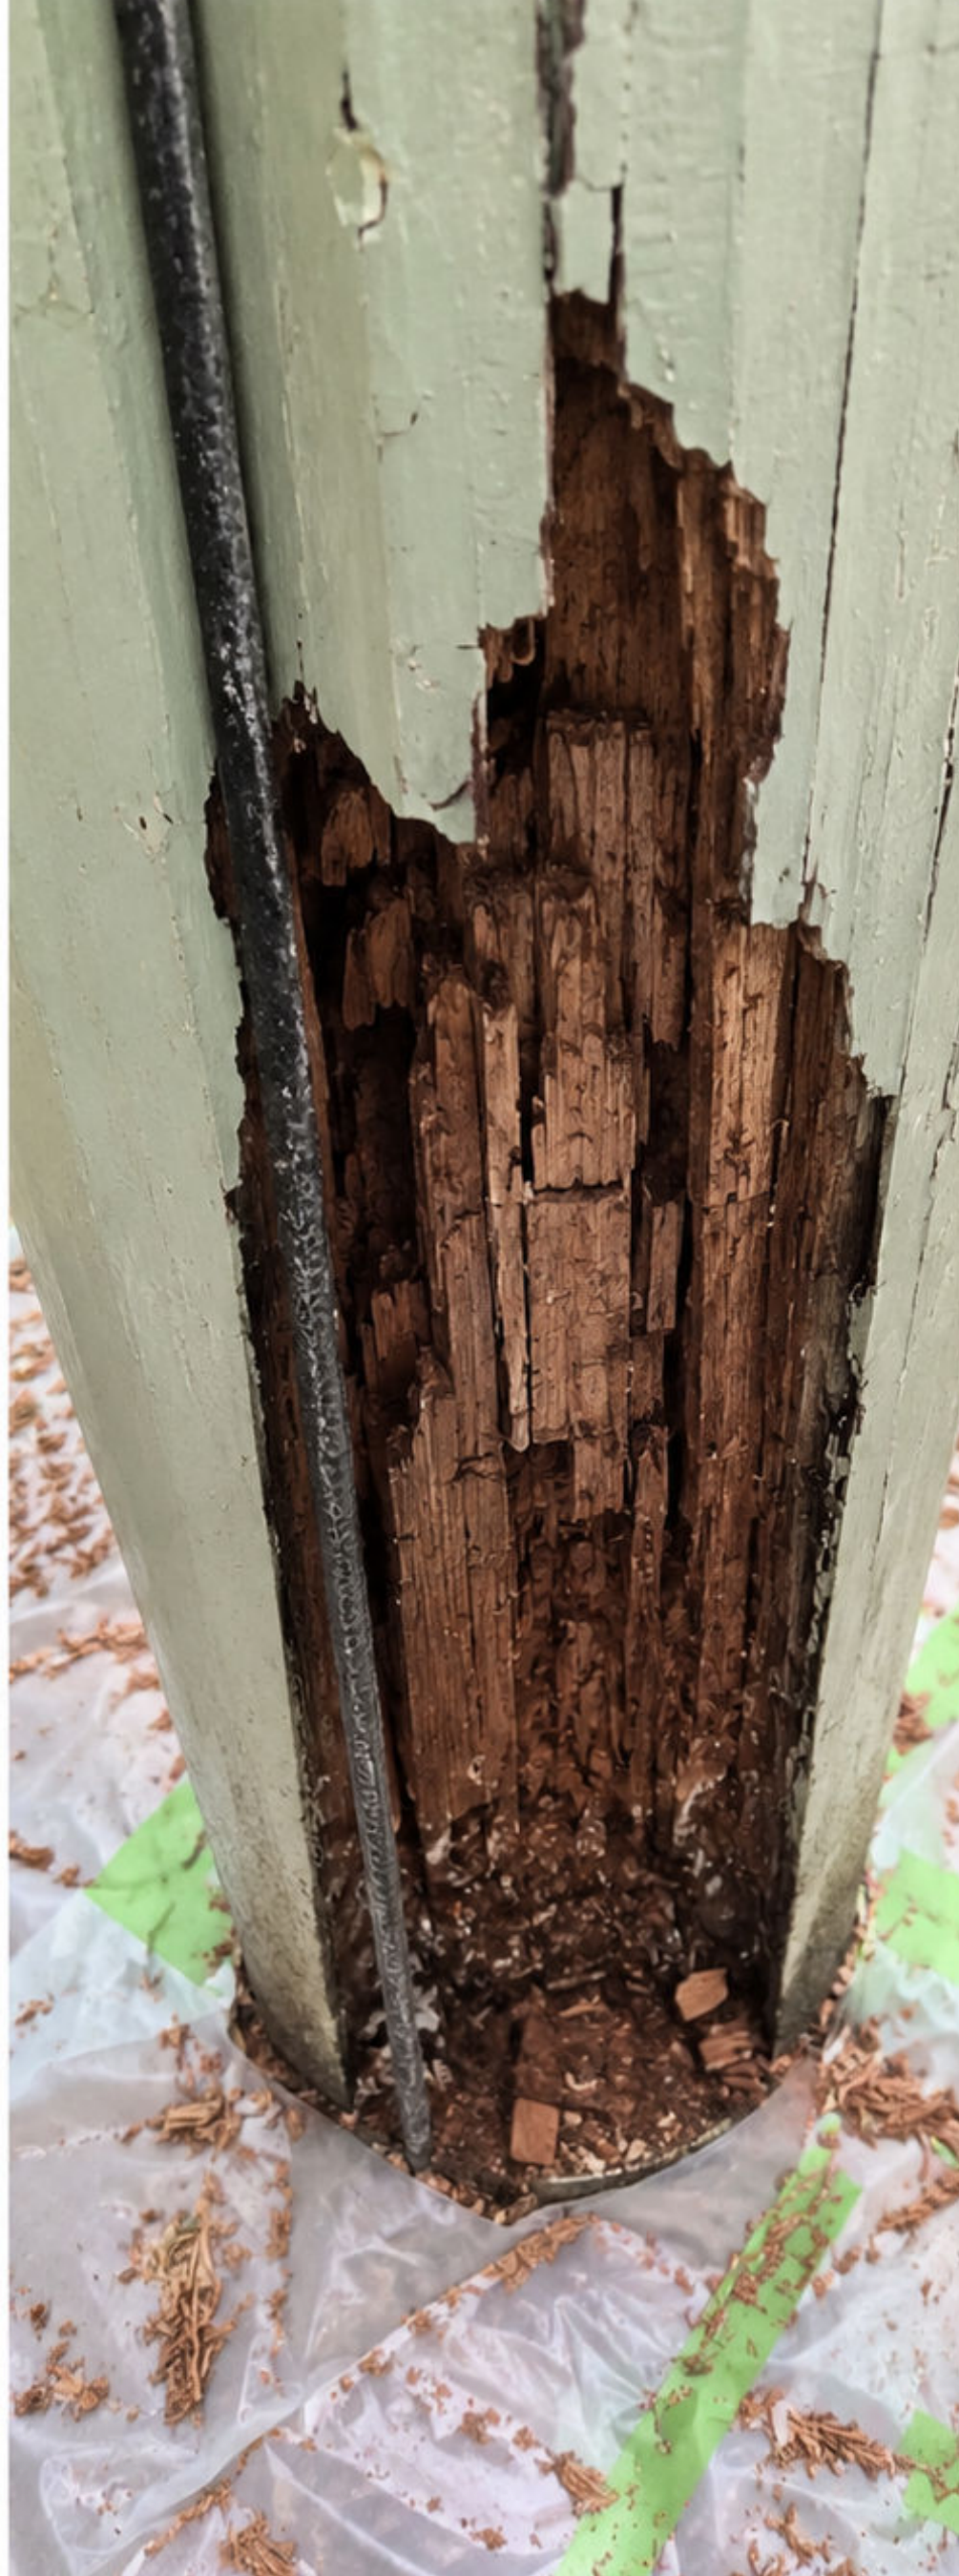
The visible deterioration was only part of the problem.

Once repairs began, extensive hidden decay was discovered inside the column.

Rather than replacing the entire component, the goal was to preserve as much sound wood as possible while restoring the damaged areas.

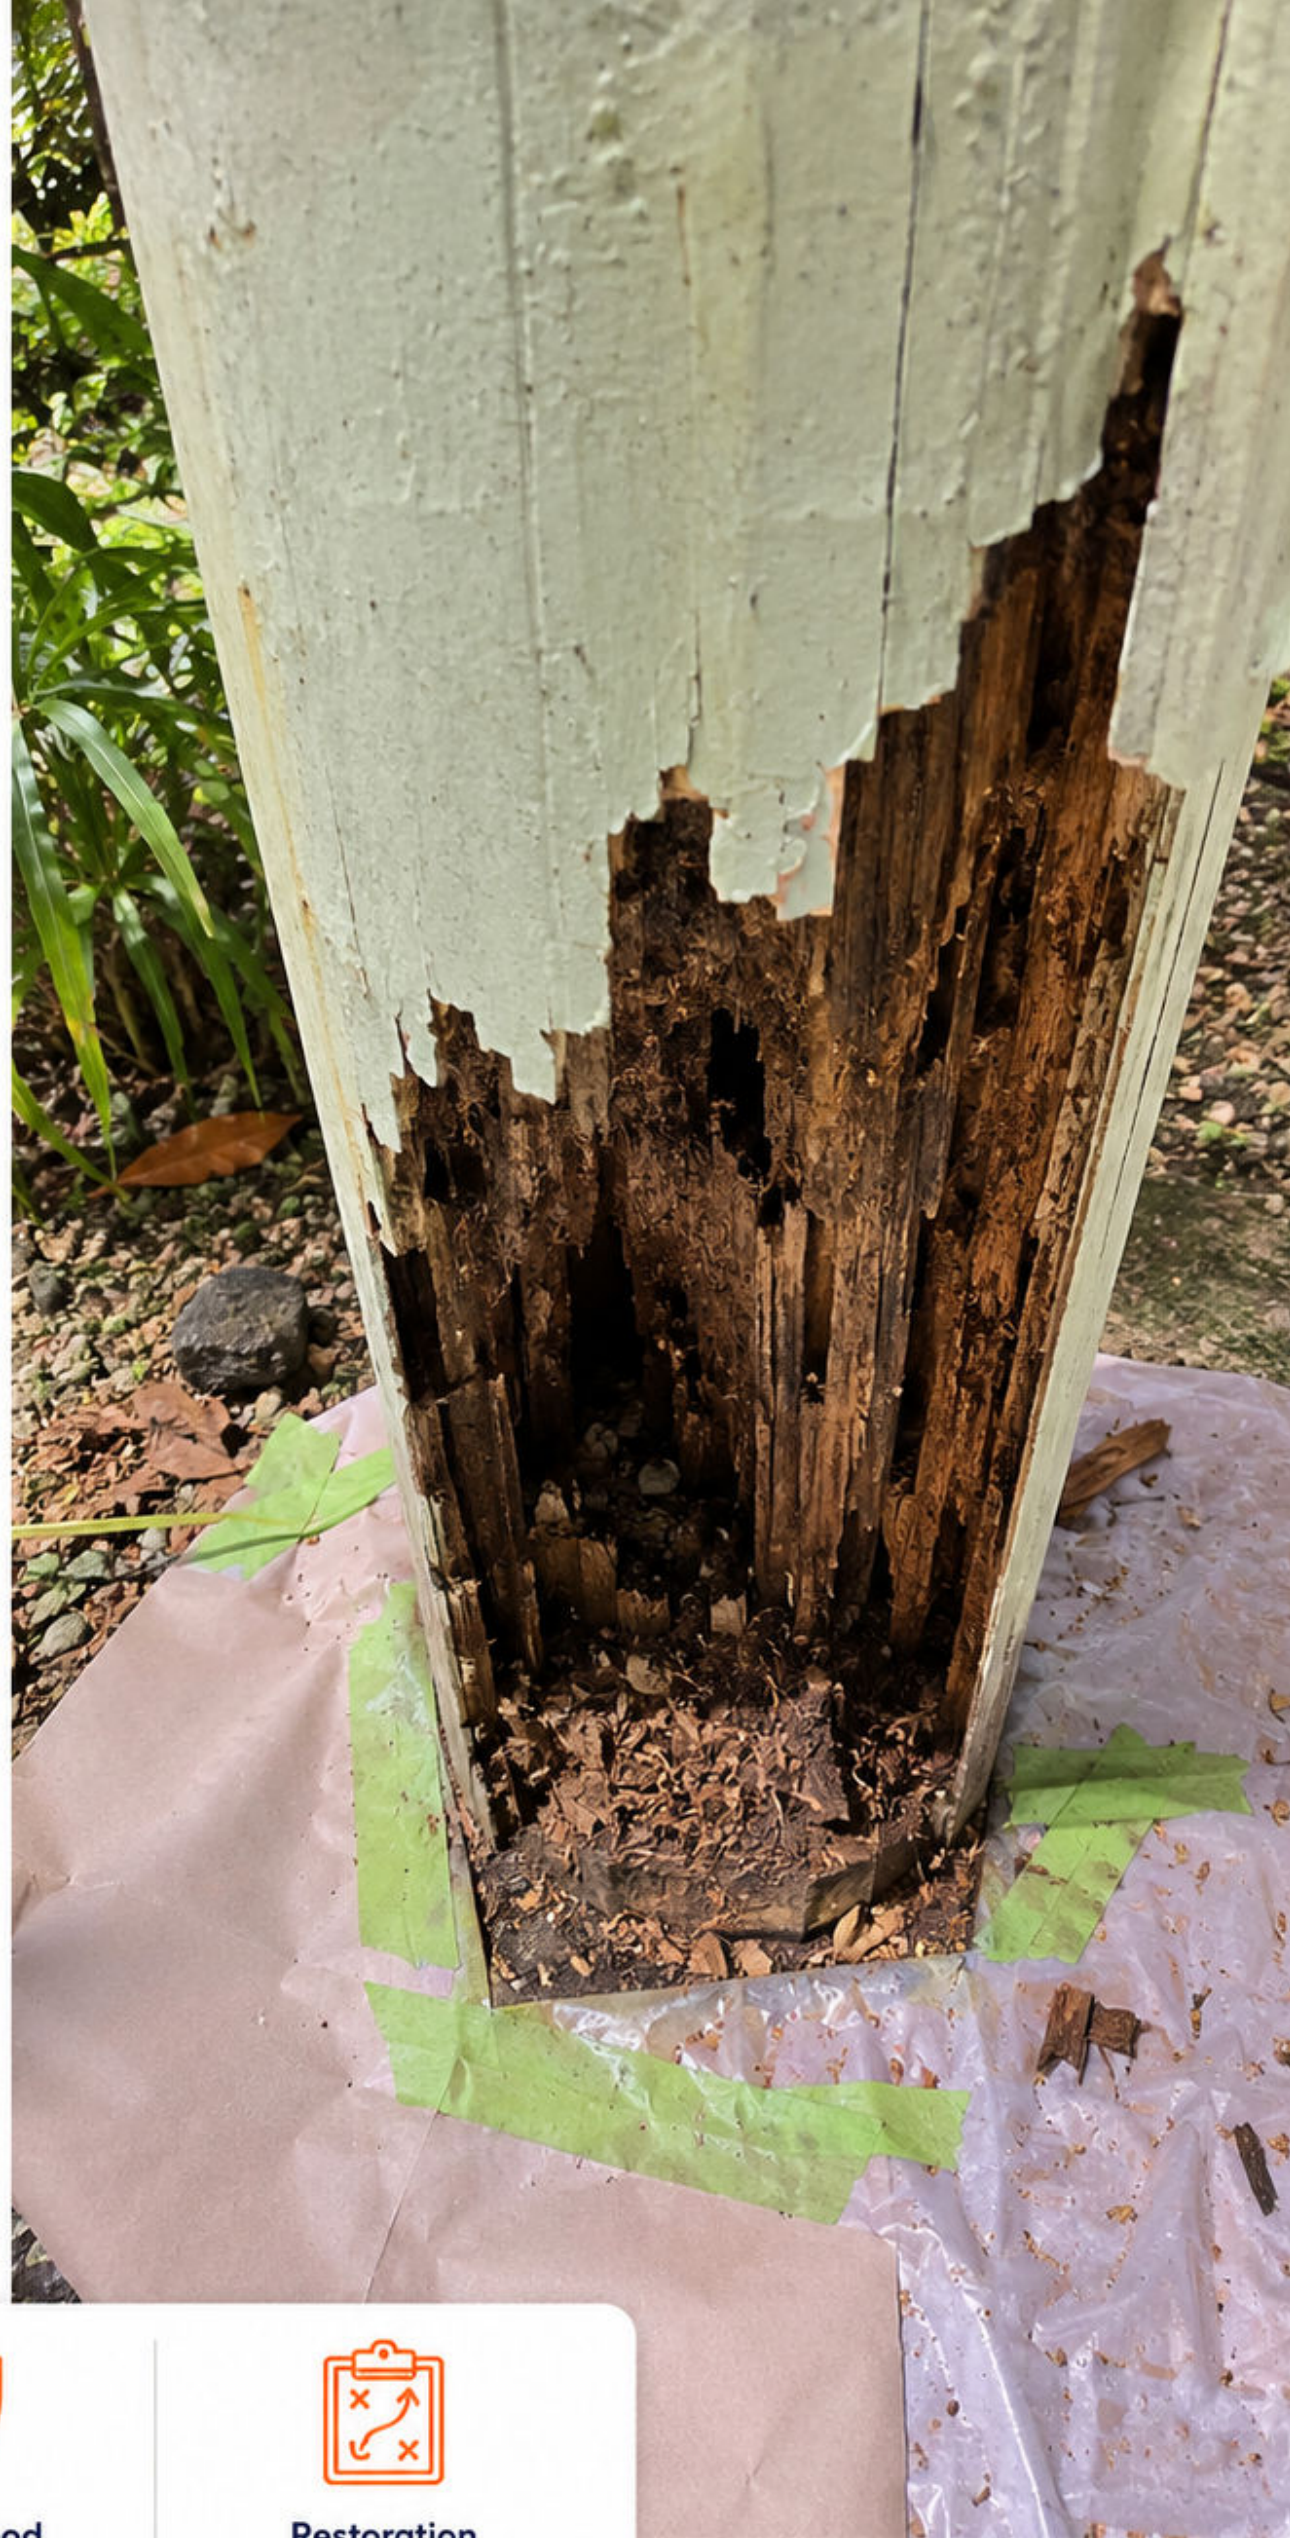
# What Was Hidden

Once the deteriorated wood was removed, the full extent of the damage became visible.

By exposing the affected areas, the maintenance team could clearly identify which portions of the column remained structurally sound and which sections required restoration.

This evaluation allowed the original architectural component to be preserved rather than unnecessarily replaced.

Hidden Damage  
Revealed

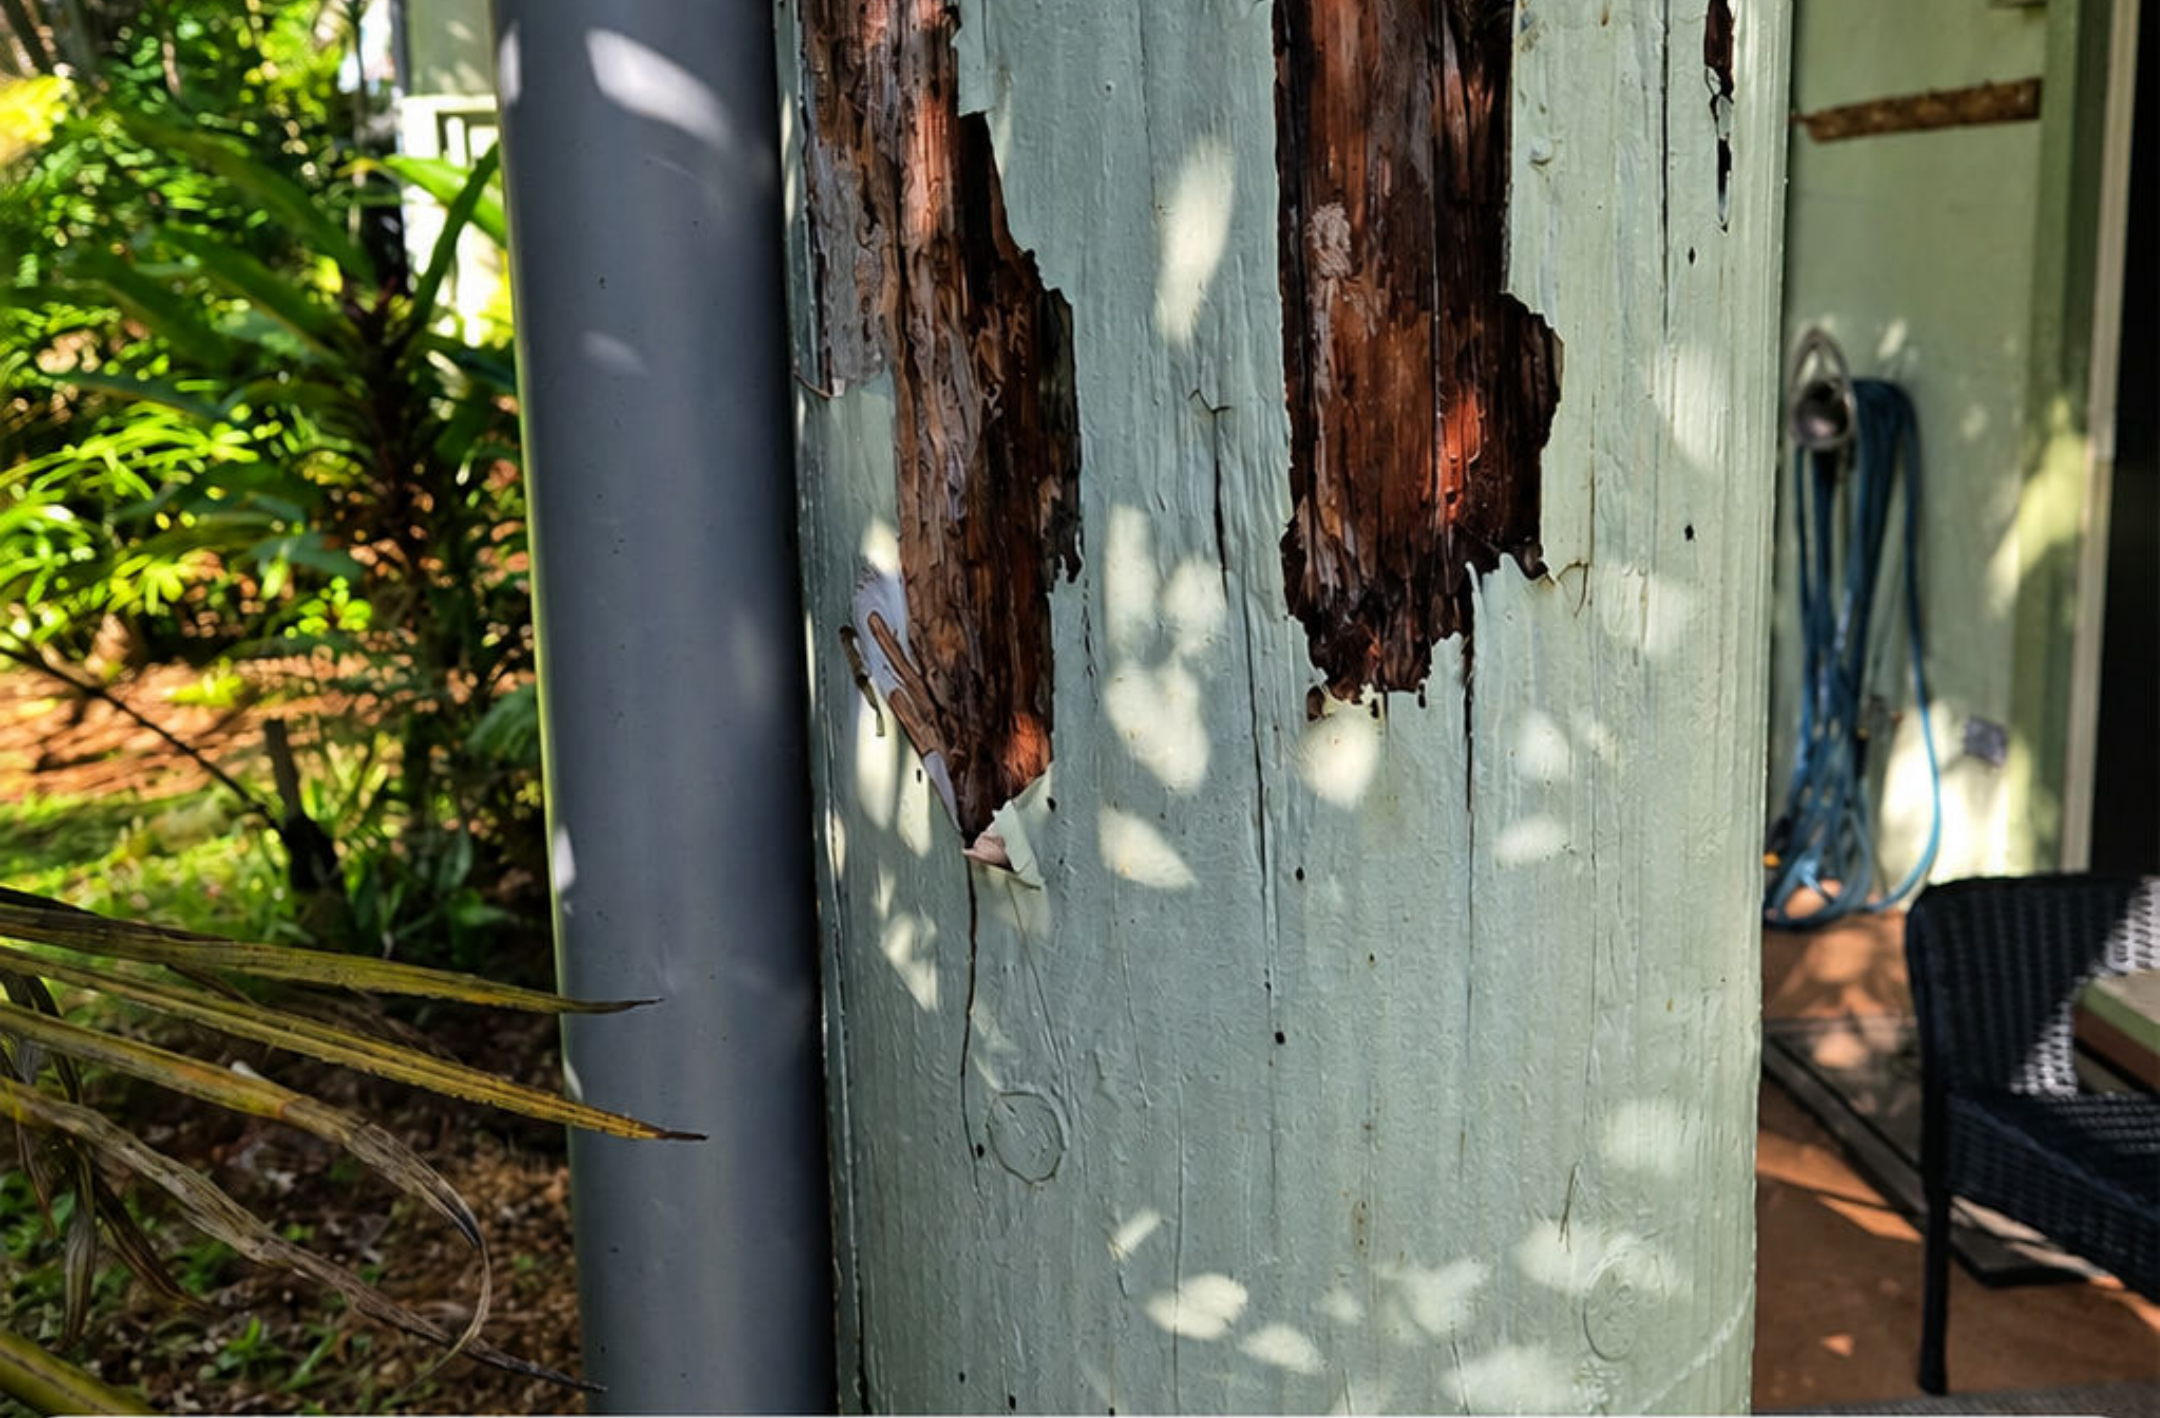
Throughout the Puamana community, deteriorated wood varied from minor decay to extensive structural deterioration.

Each repair location was individually evaluated to determine where sound wood could be preserved and damaged areas restored.

Rather than replacing entire architectural components, the restoration strategy focused on repairing only what was necessary.

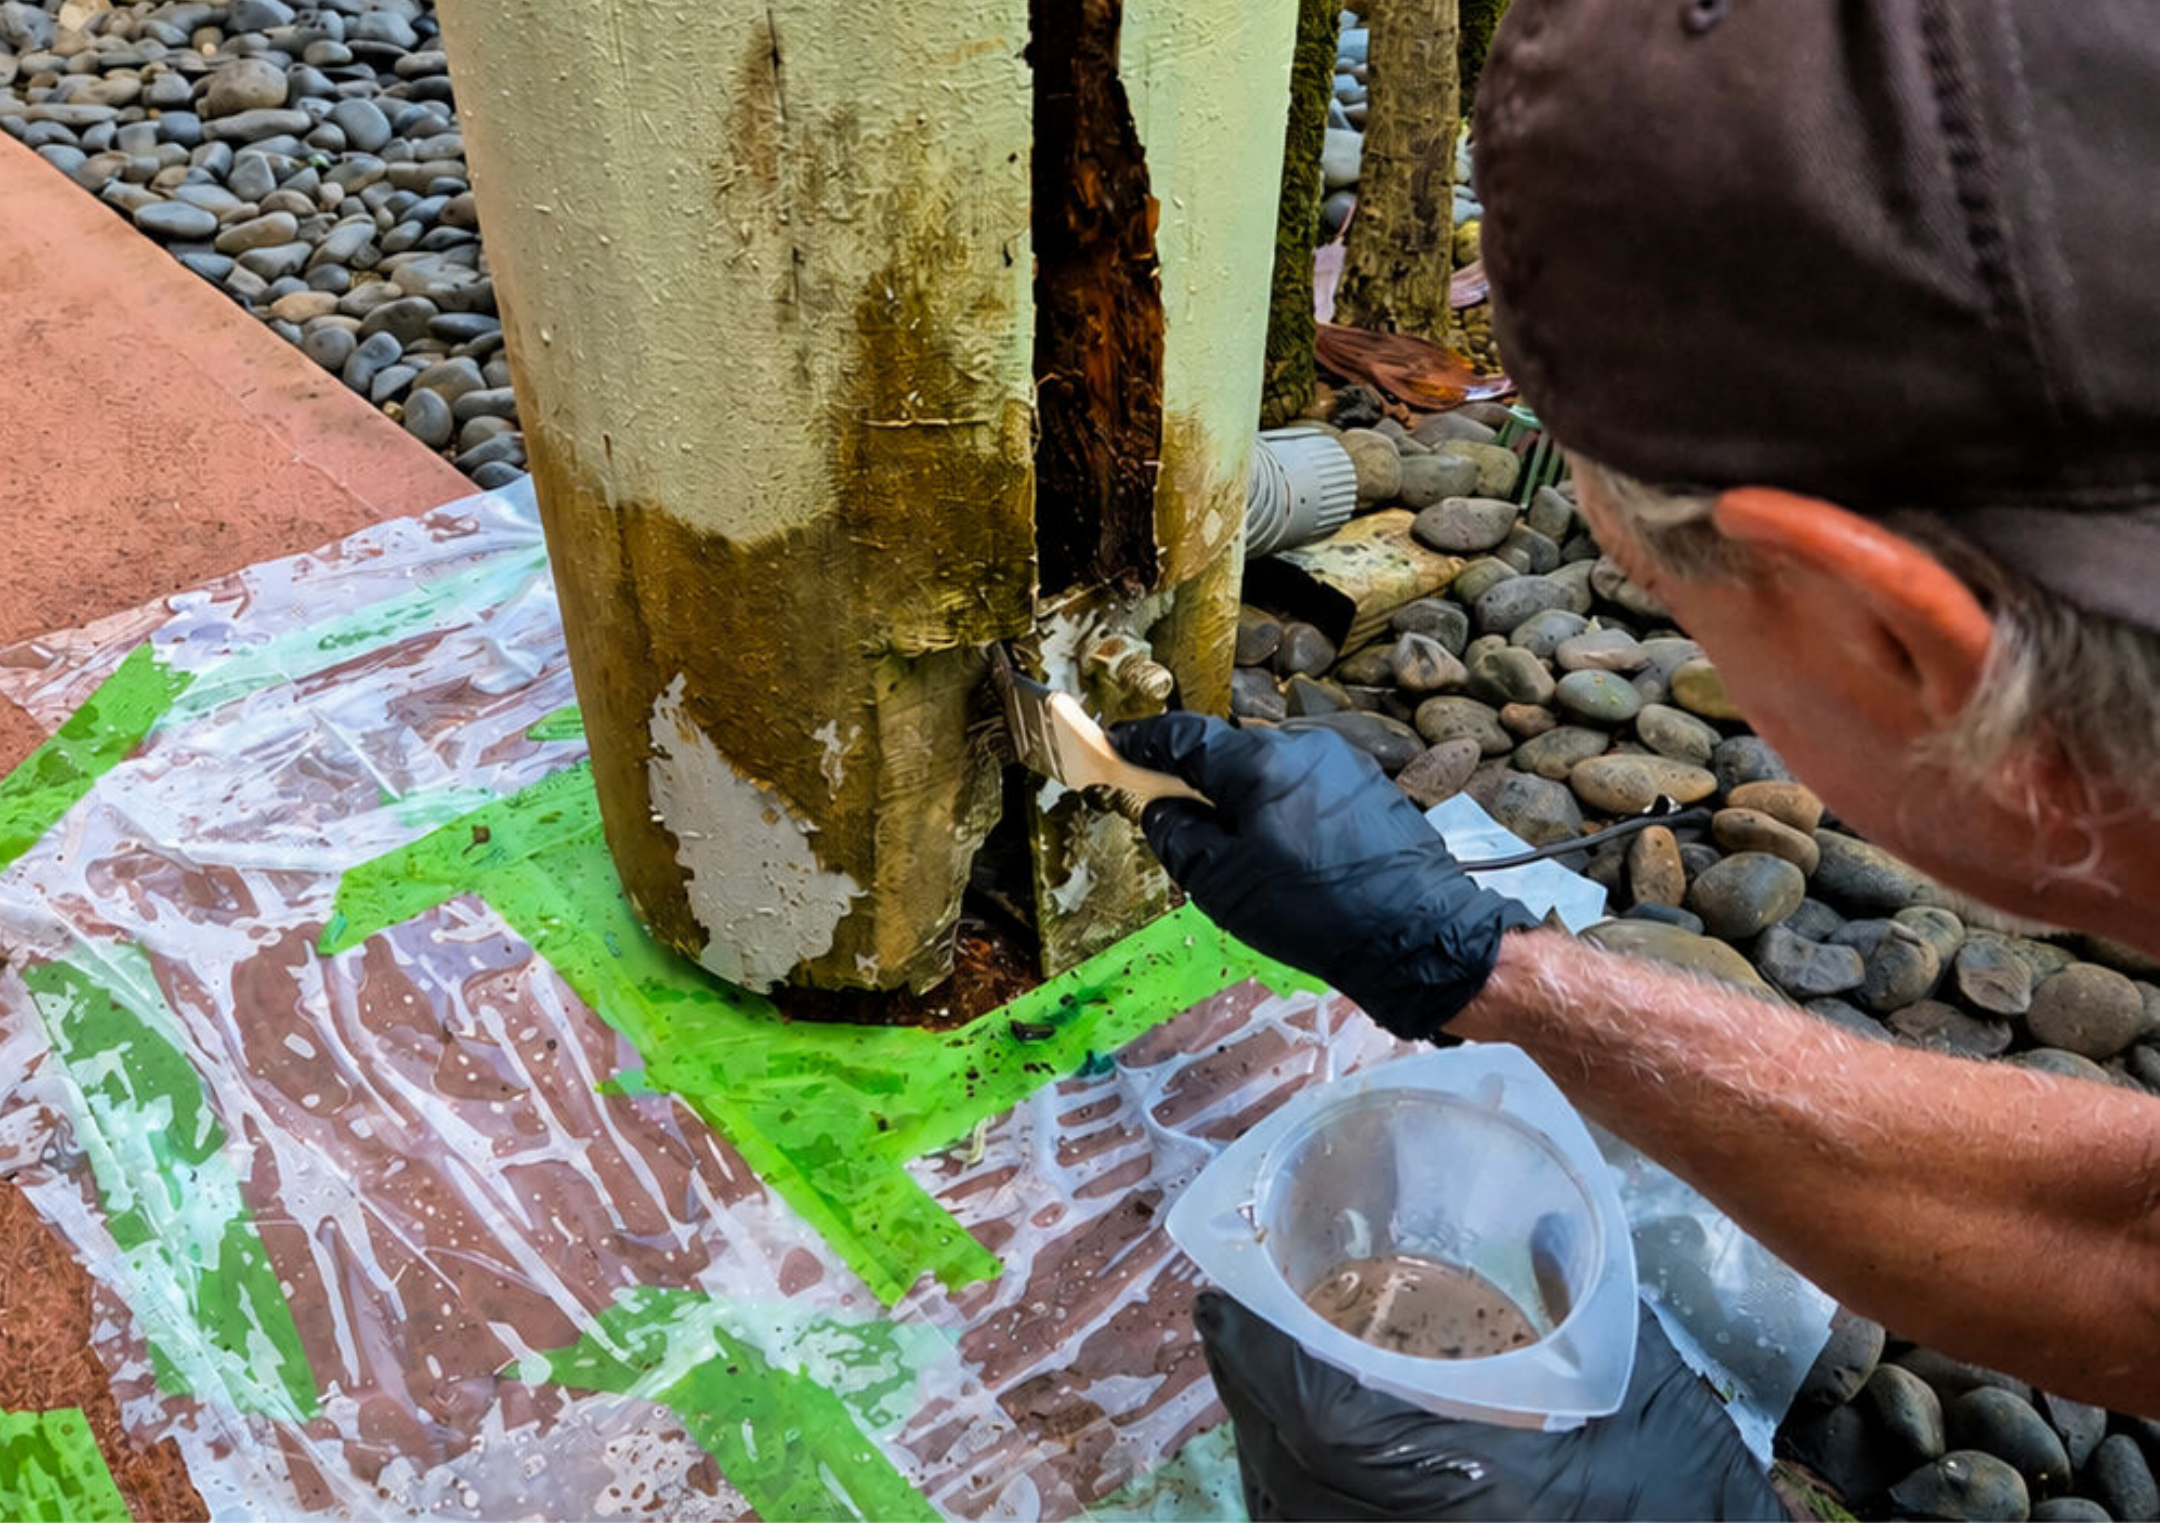
# Strengthening the Remaining Wood

With all deteriorated wood removed, the remaining sound wood was treated with **WRP Liquid Wood Consolidant**.

The consolidant penetrates deep into weakened wood fibers, helping strengthen and stabilize the remaining wood before rebuilding begins. By preserving sound material instead of replacing it, the original architectural component can often be restored while maintaining its character and integrity.

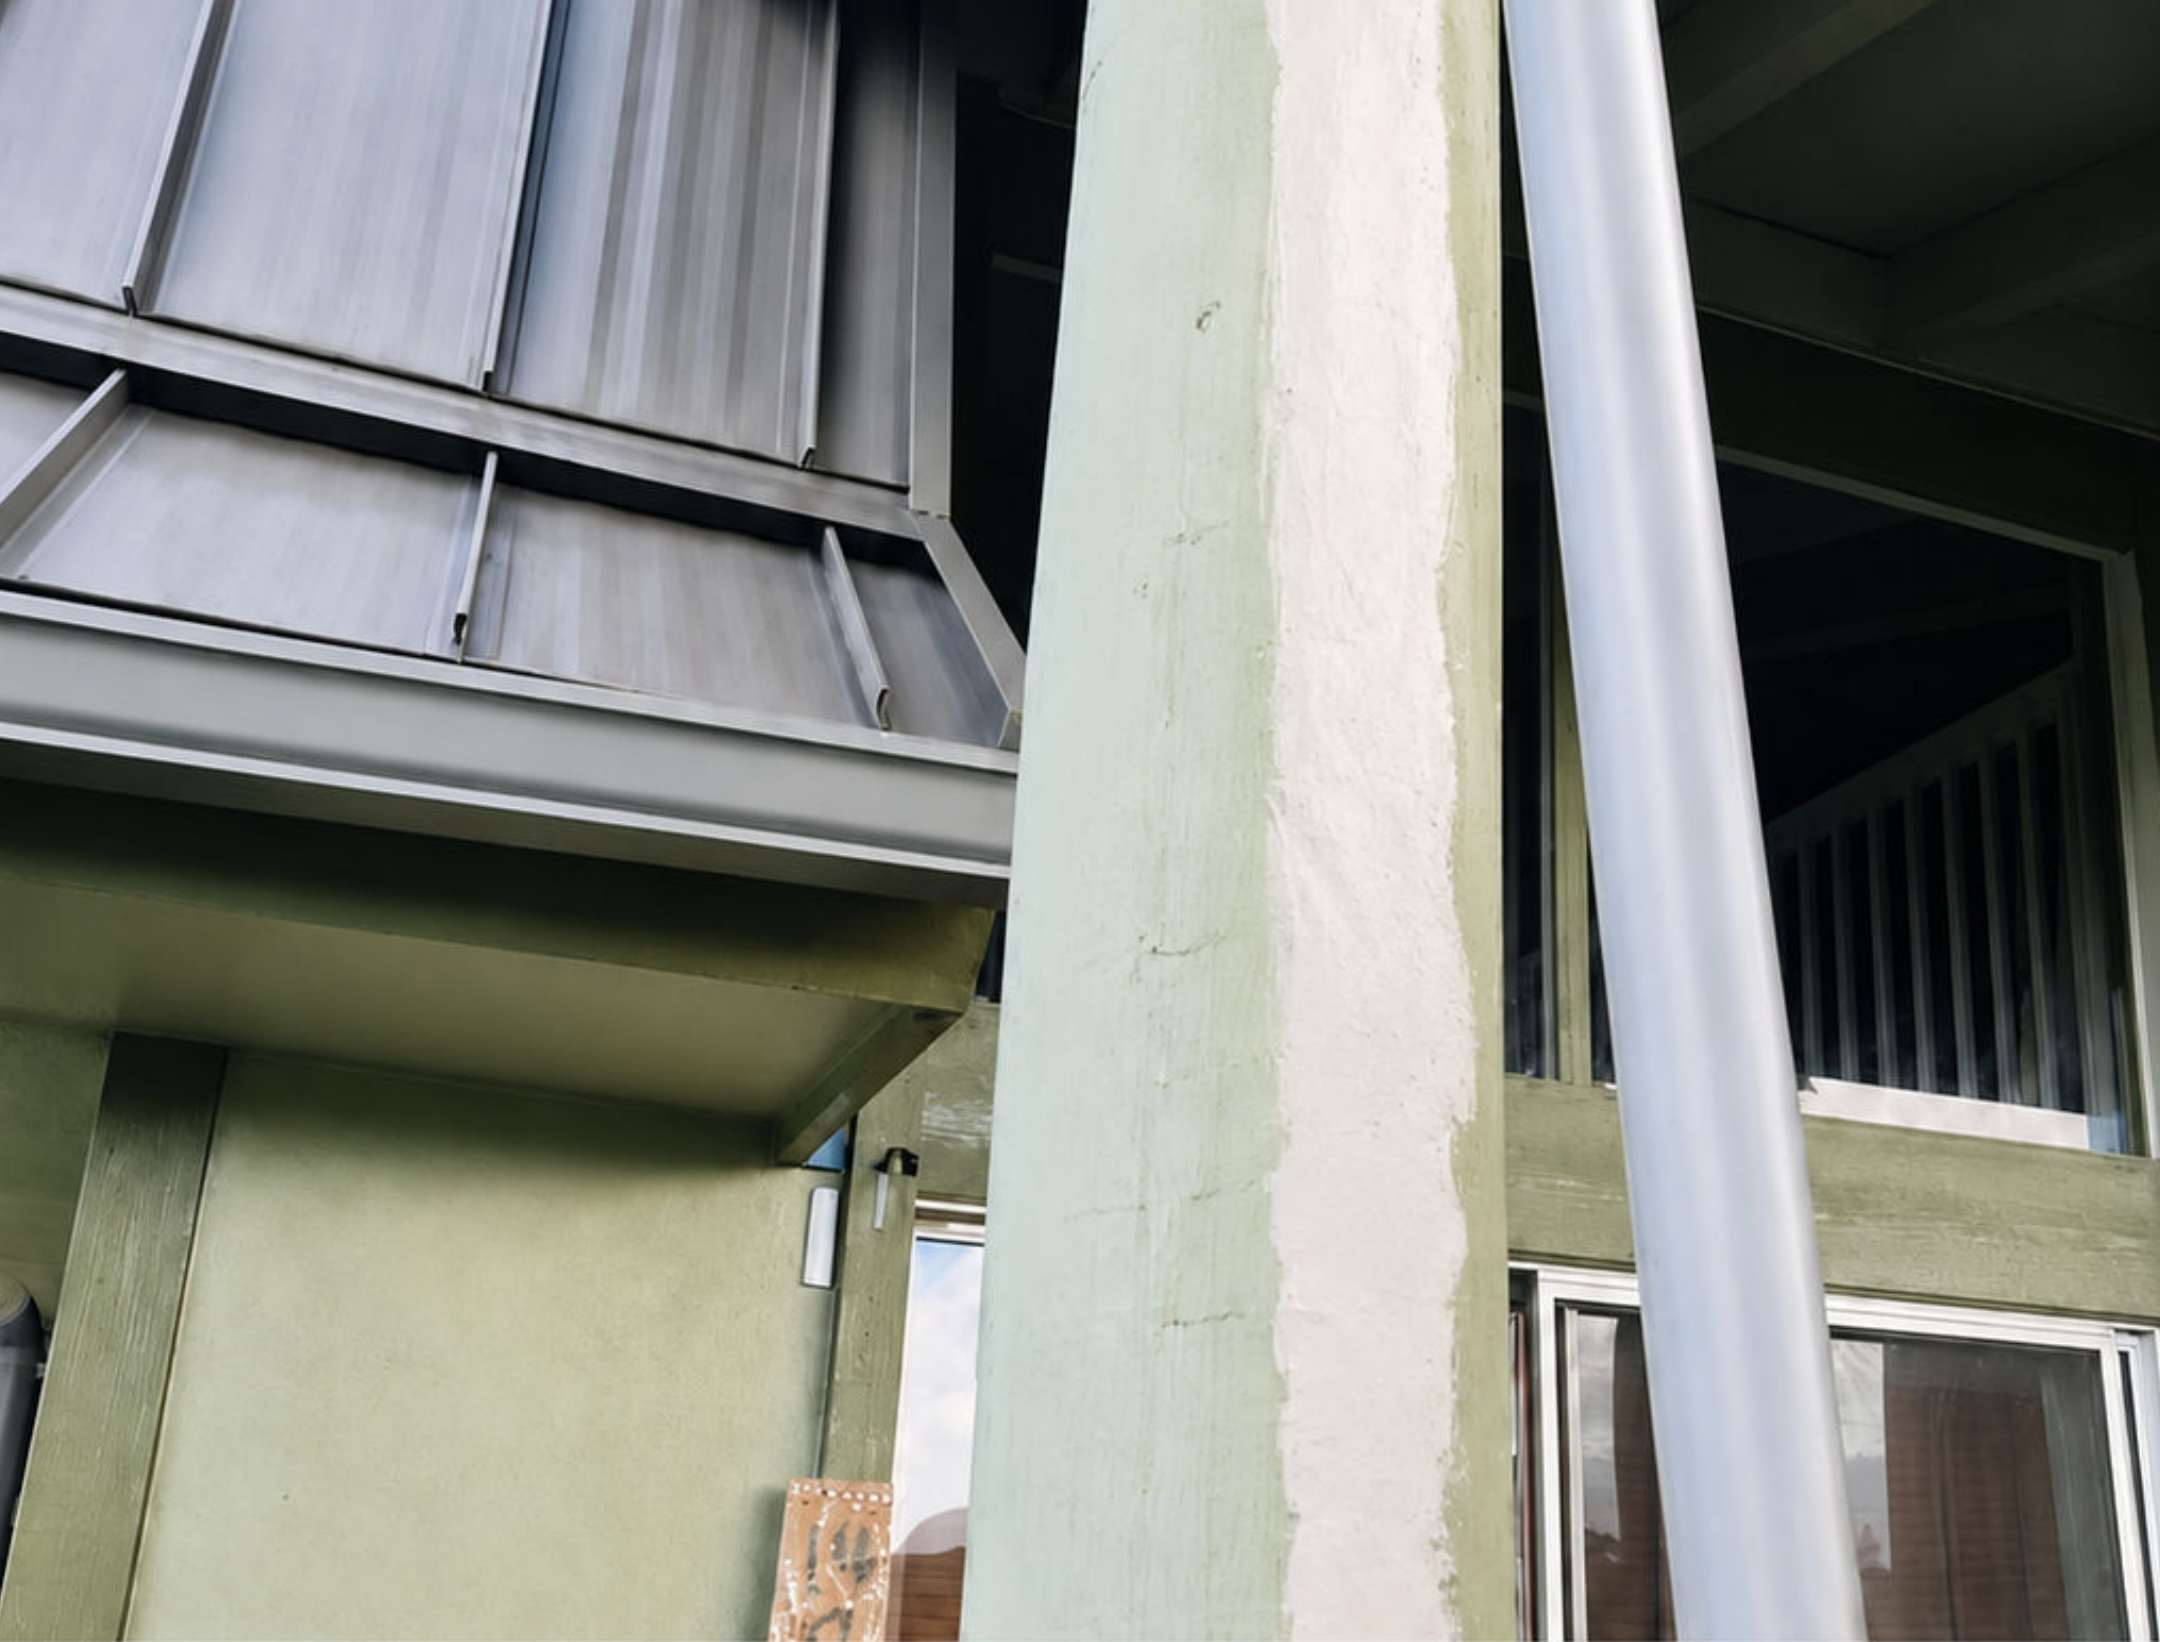
# Rebuilding the Missing Wood

Once the remaining wood was strengthened, **WRP Epoxy Dough** was used to replace the missing sections of the column.

The repair material was carefully applied, shaped, and bonded to the existing wood, allowing the original member to be restored while preserving as much of the sound wood as possible.

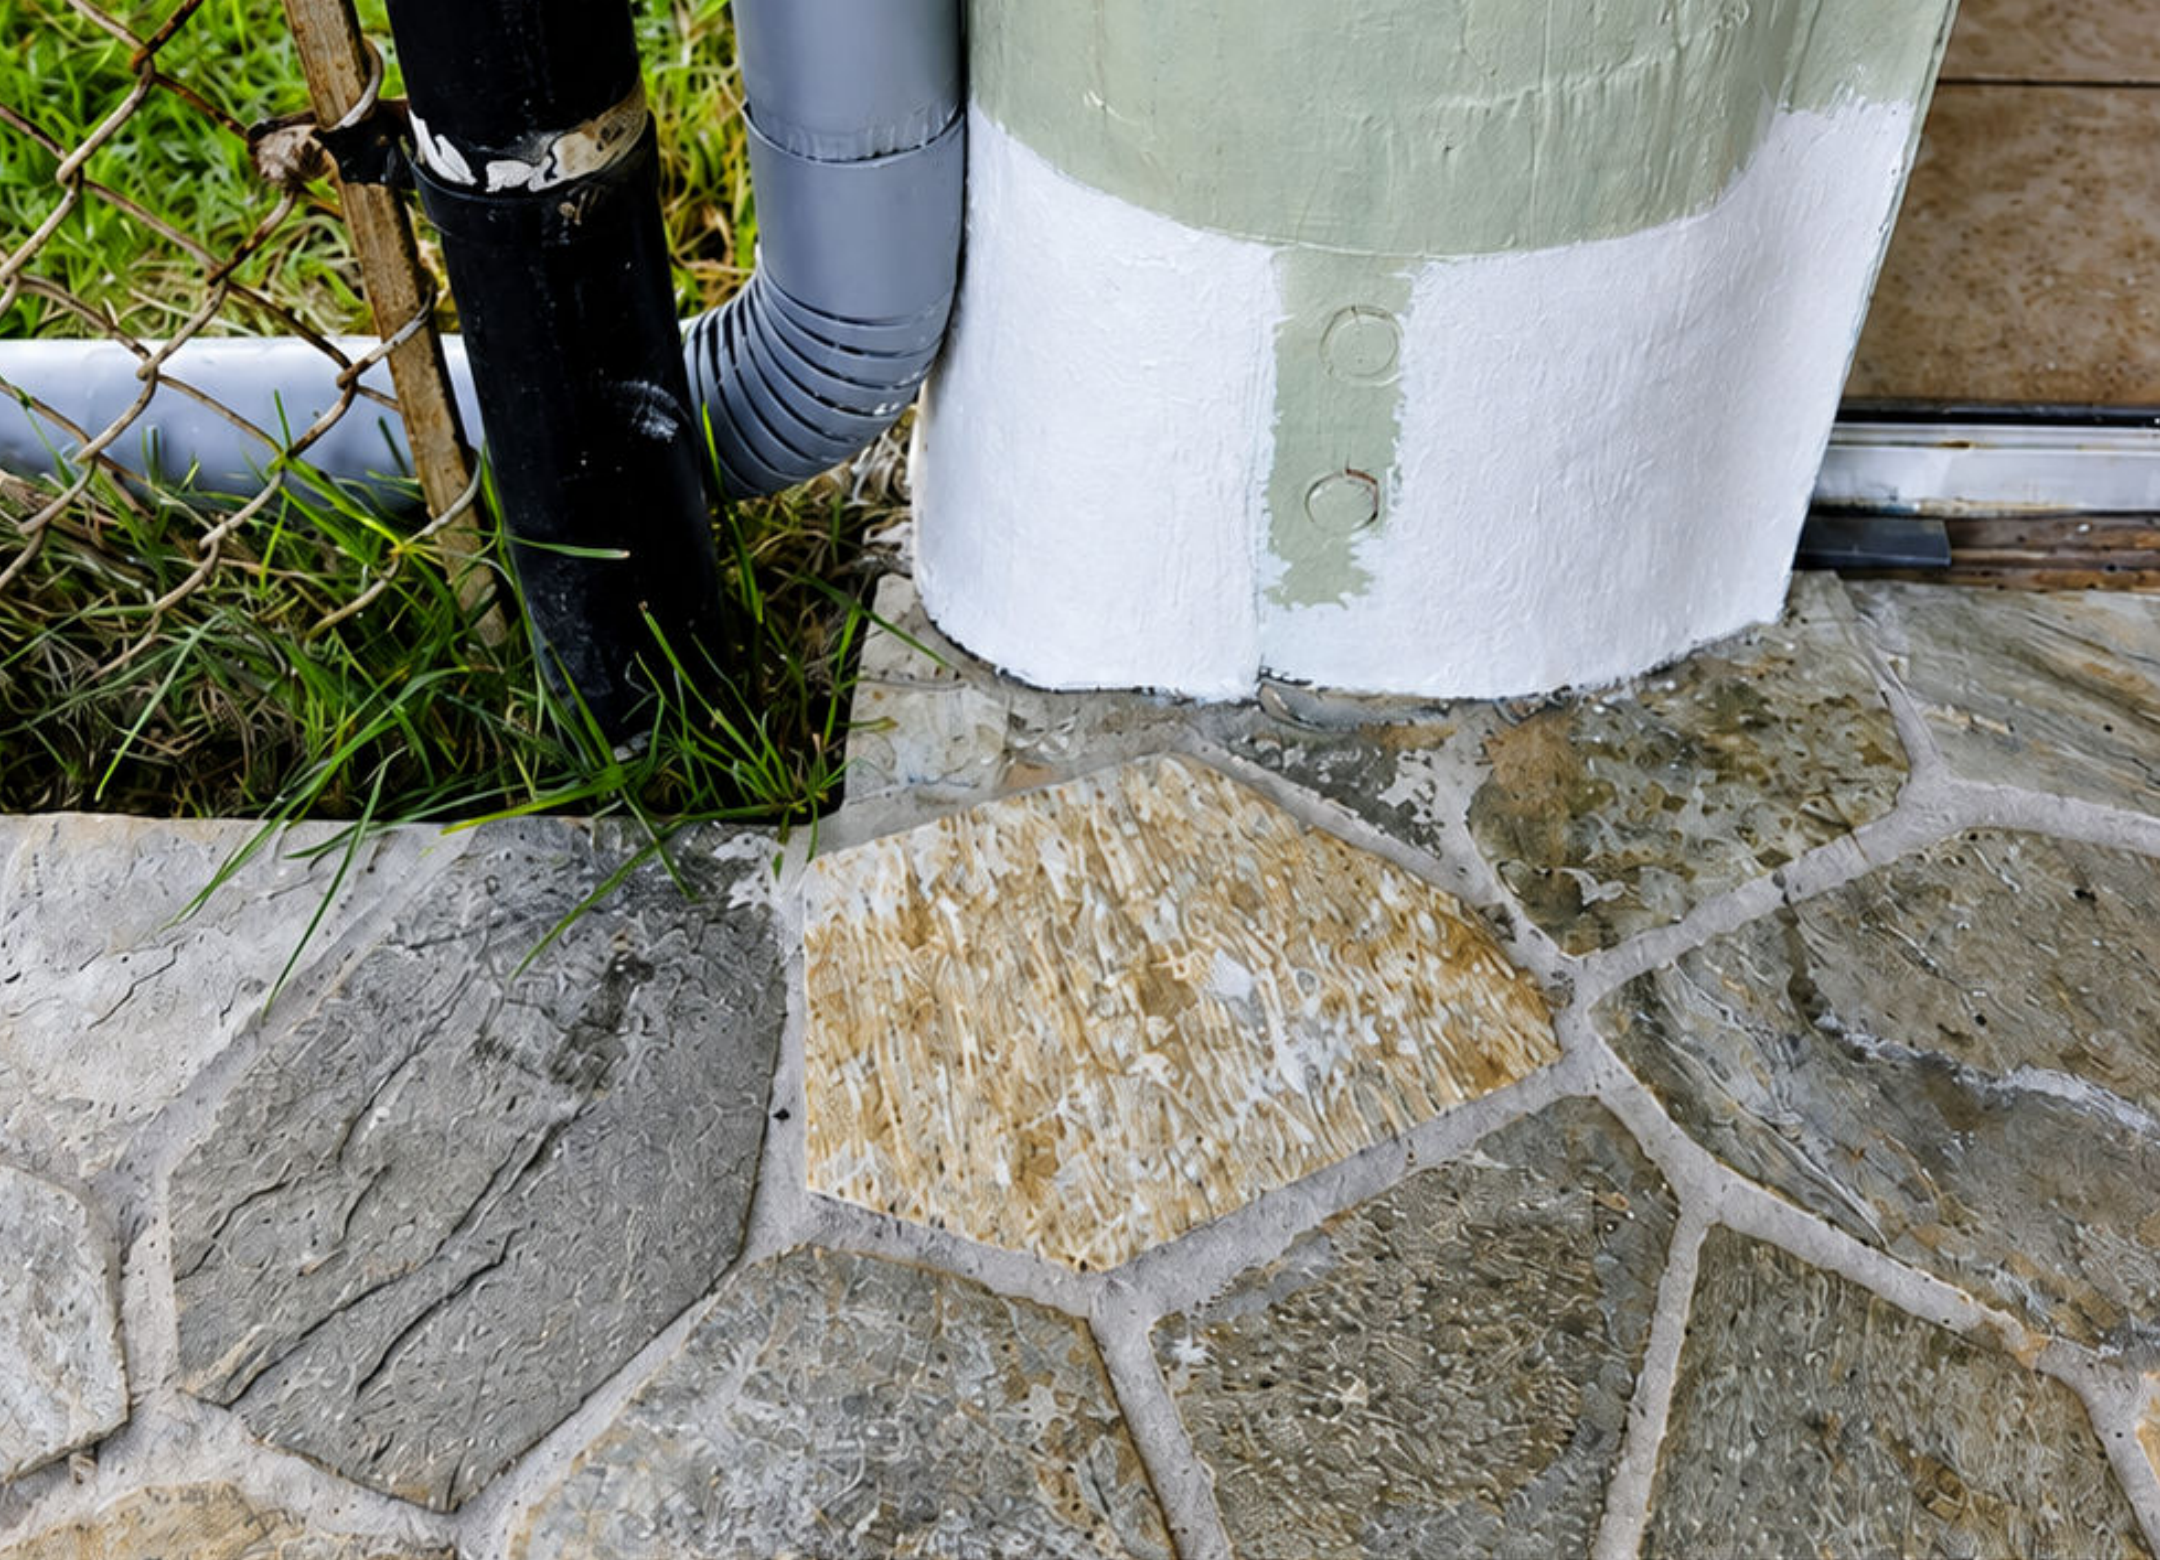
# Shaping the Repair to Match the Original Wood

After the column was rebuilt, **WRP Topping Compound** was applied to refine the surface and restore the original profile.

This step allows the repair to be shaped, detailed, and blended into the surrounding wood before final finishing.

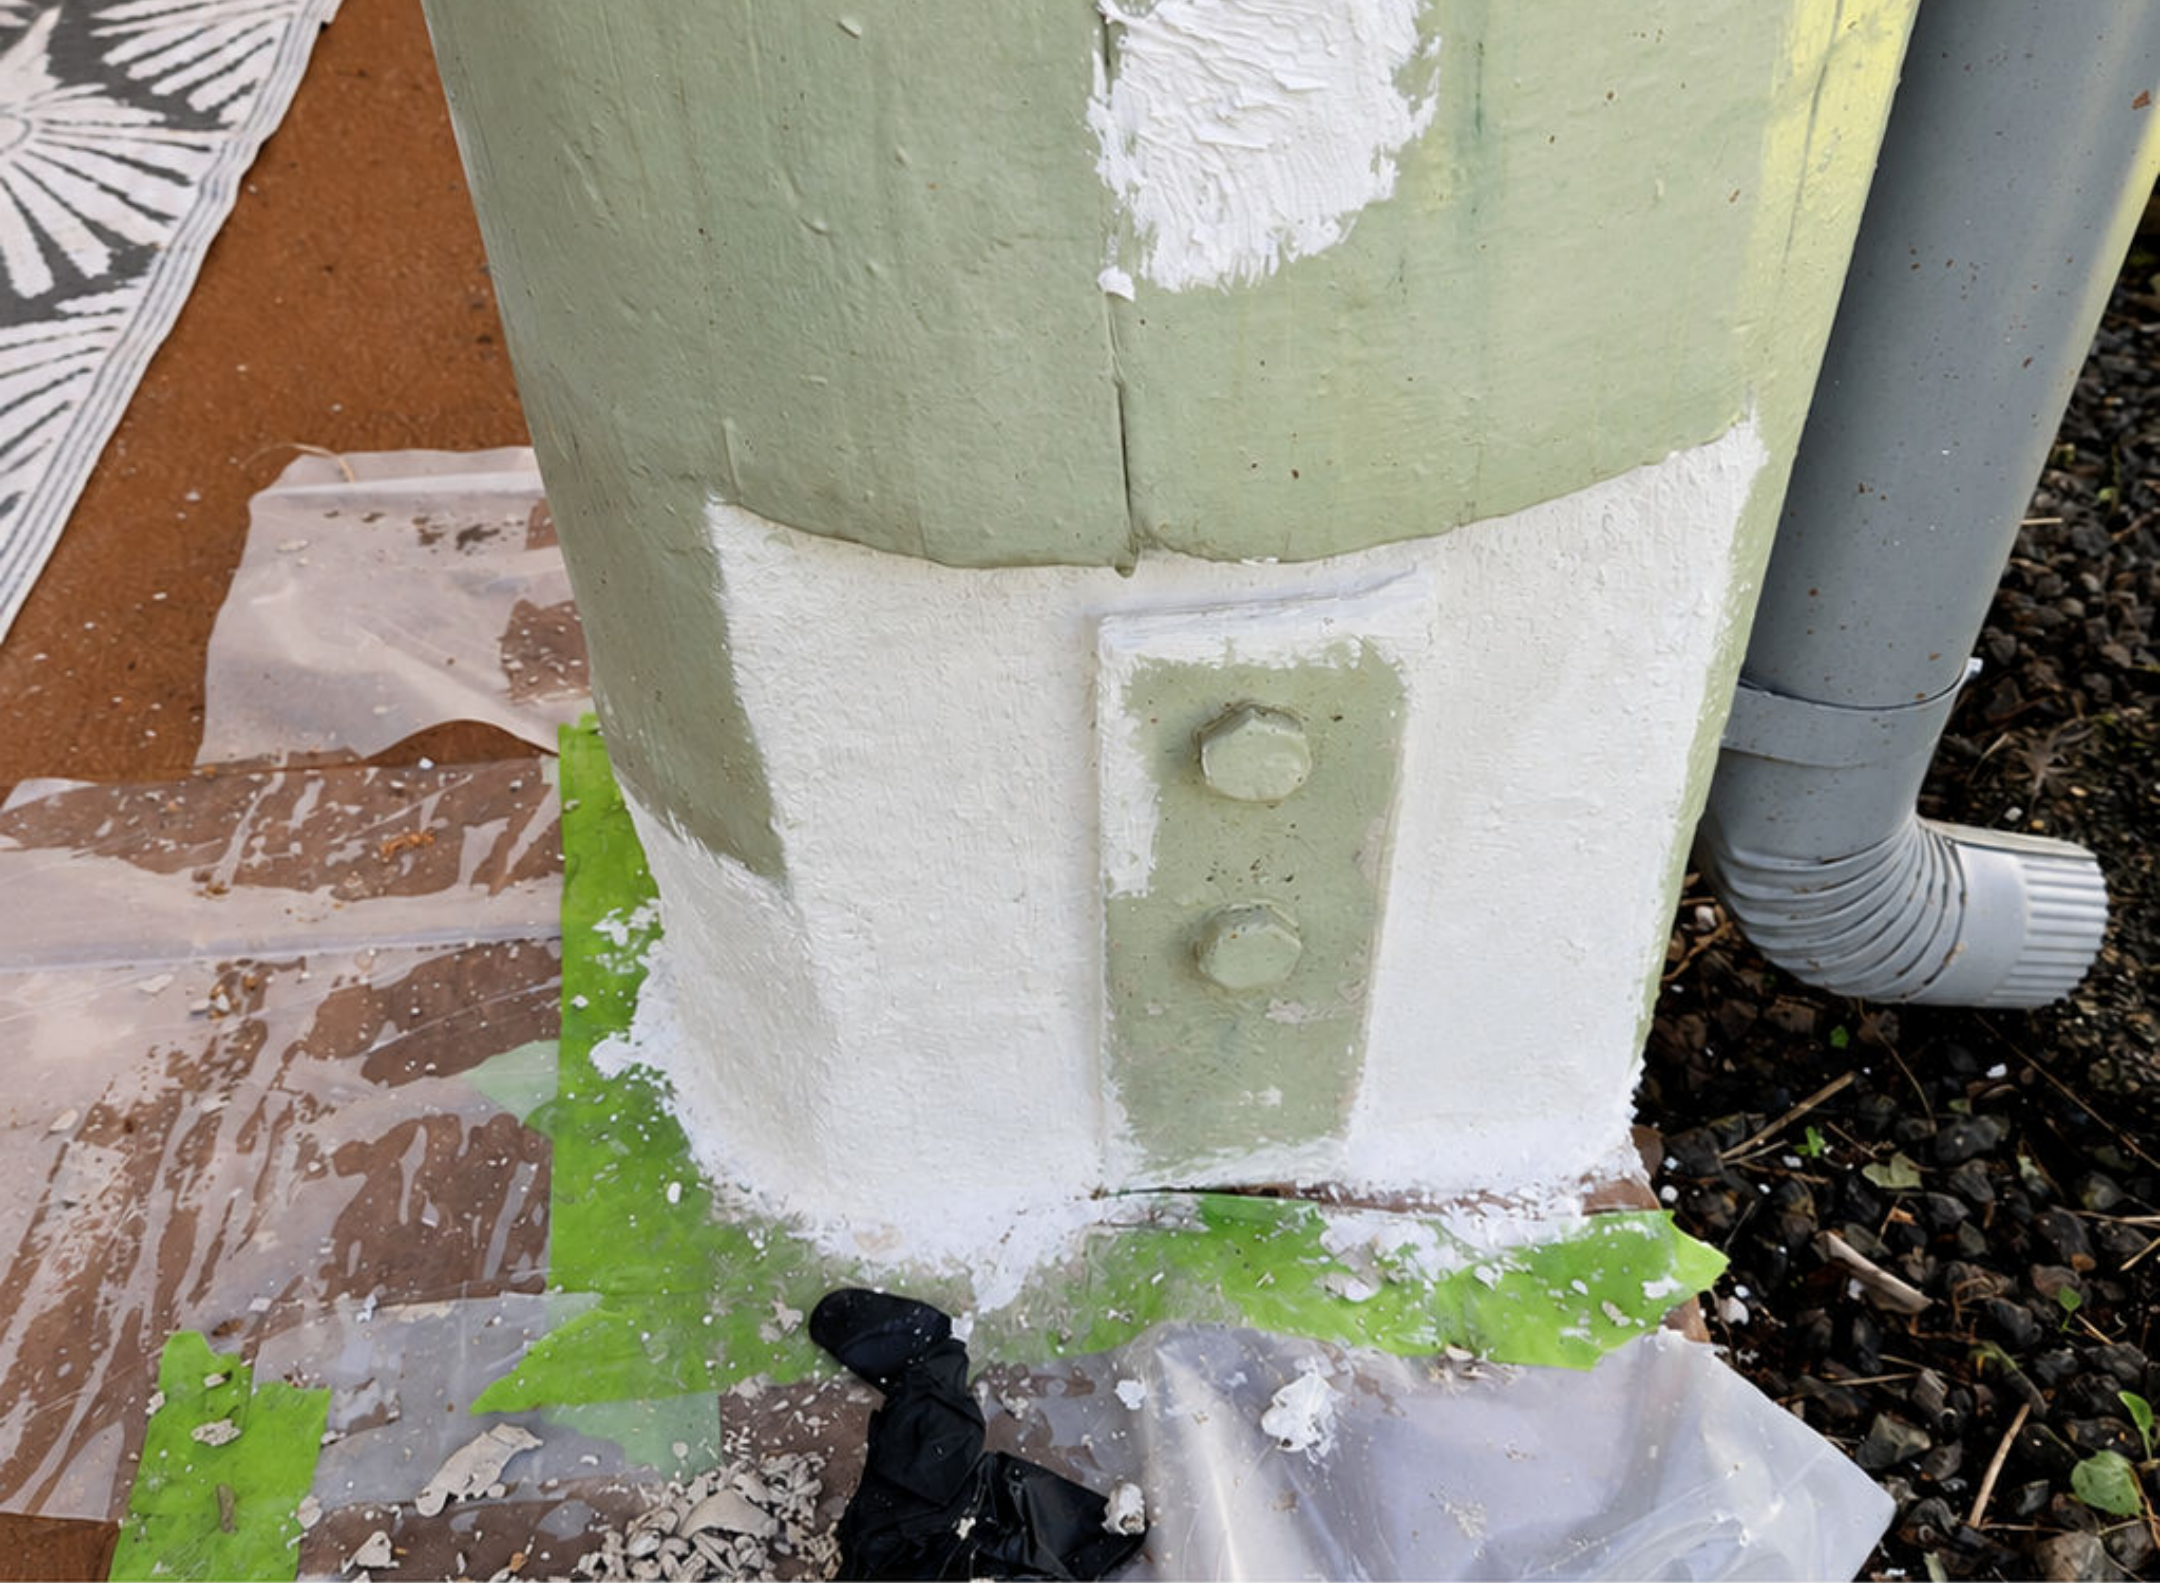
# Ready for Primer and Paint

Once the repair was fully shaped and refined, **WRP Topping Compound** was applied to smooth and prepare the surface.

The completed restoration blended seamlessly with the original wood, preserving the existing structure while avoiding unnecessary replacement.
