# Puamana Homeowners Association

## Wood Restoration Project

Helping a 97-unit community in Princeville, Kauai preserve existing wood and avoid an estimated **\$1.4 million** in replacement costs.

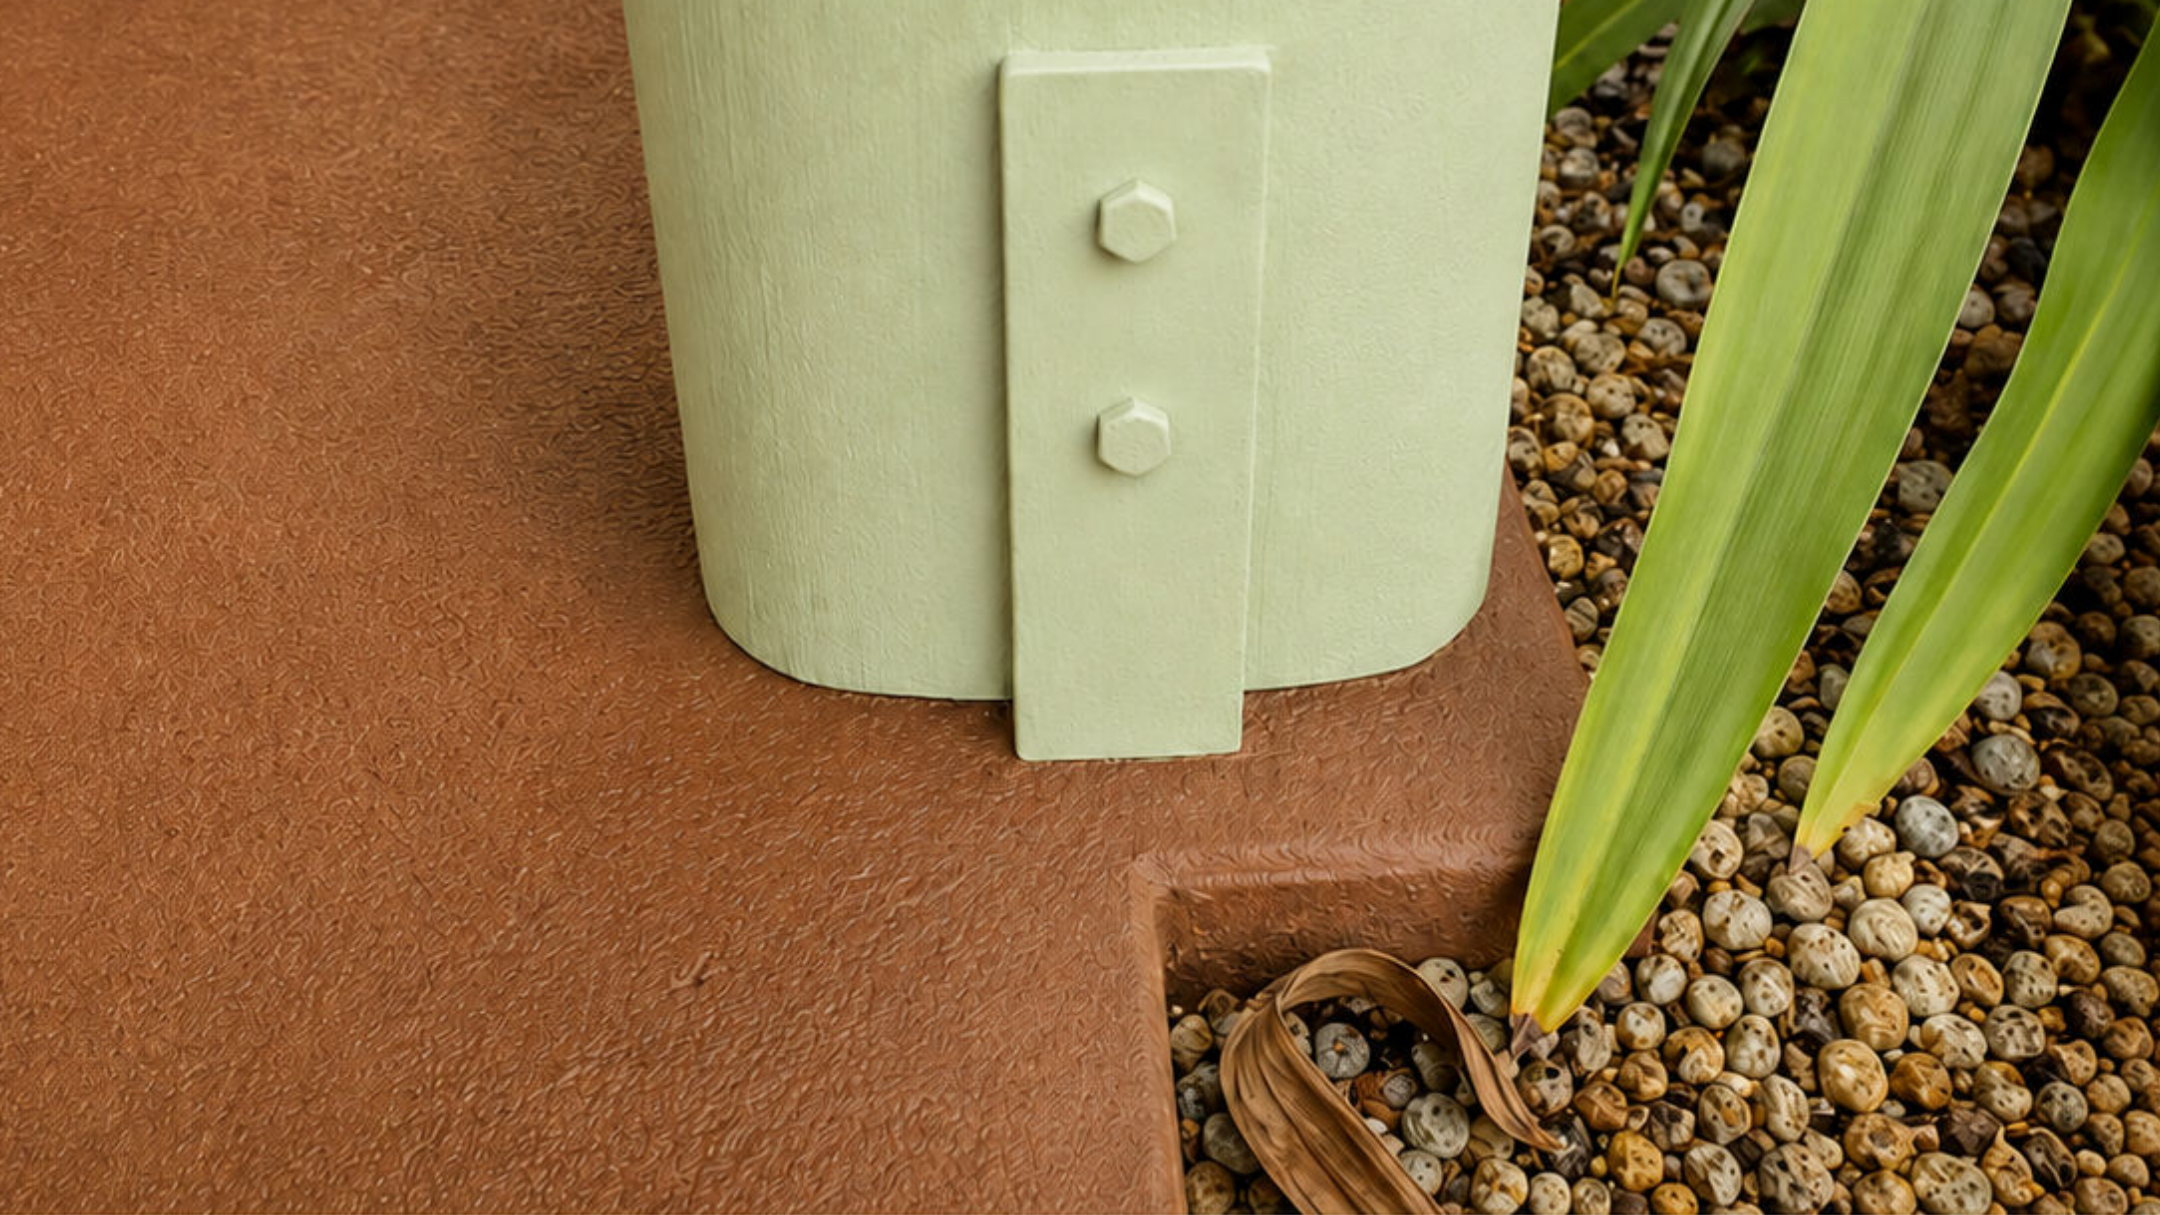
PROJECT COMPLETE

# Restored to Last. Built to Preserve.

The Puamana Homeowners Association project demonstrates how thoughtful restoration can preserve existing wood, extend service life, and reduce the need for costly replacement.

Through planning, professional training, and the WRP Wood Restoration System, the community restored damaged wood while preserving the character of its original architecture.
